Inventive Tricks and Fixes Aboard the ISS

MacGyvering Station

International Space Station

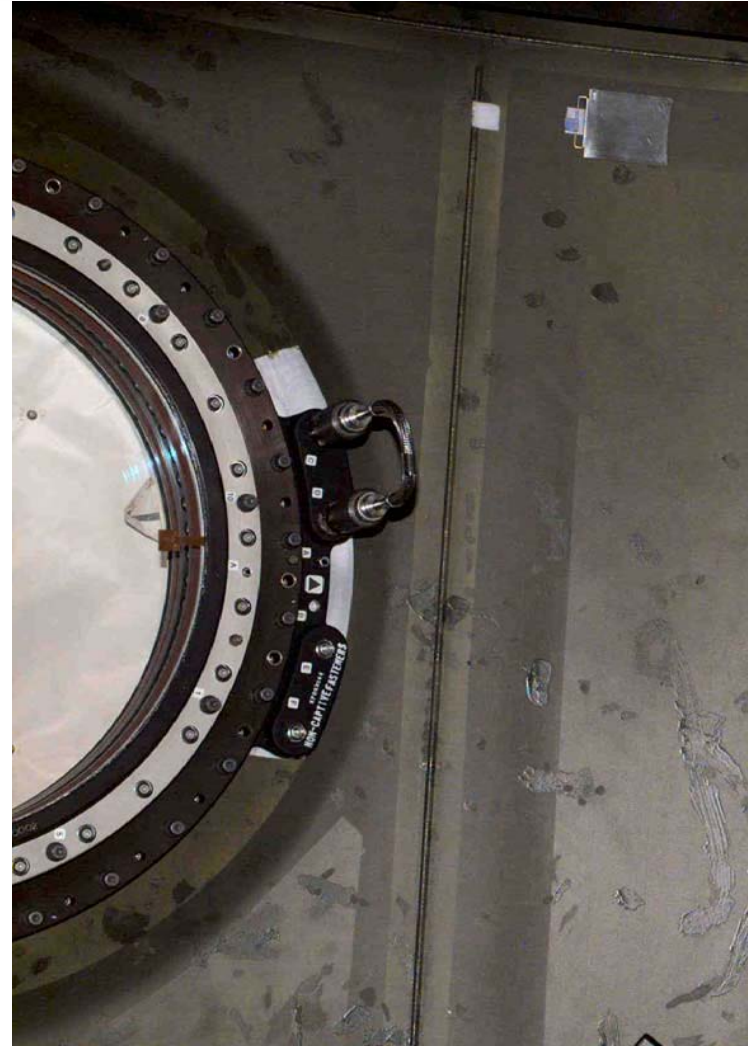
The Window Box (2004 / Inc 9)

- **Problem:** crew uses a hose to space as a handhold to look out the window.
- **Impact:** station leaks too much.
- **Workaround:** build a box around the hose.
Originally it was to be built from on-orbit supplies, but eventually a kit to build the box was flown.

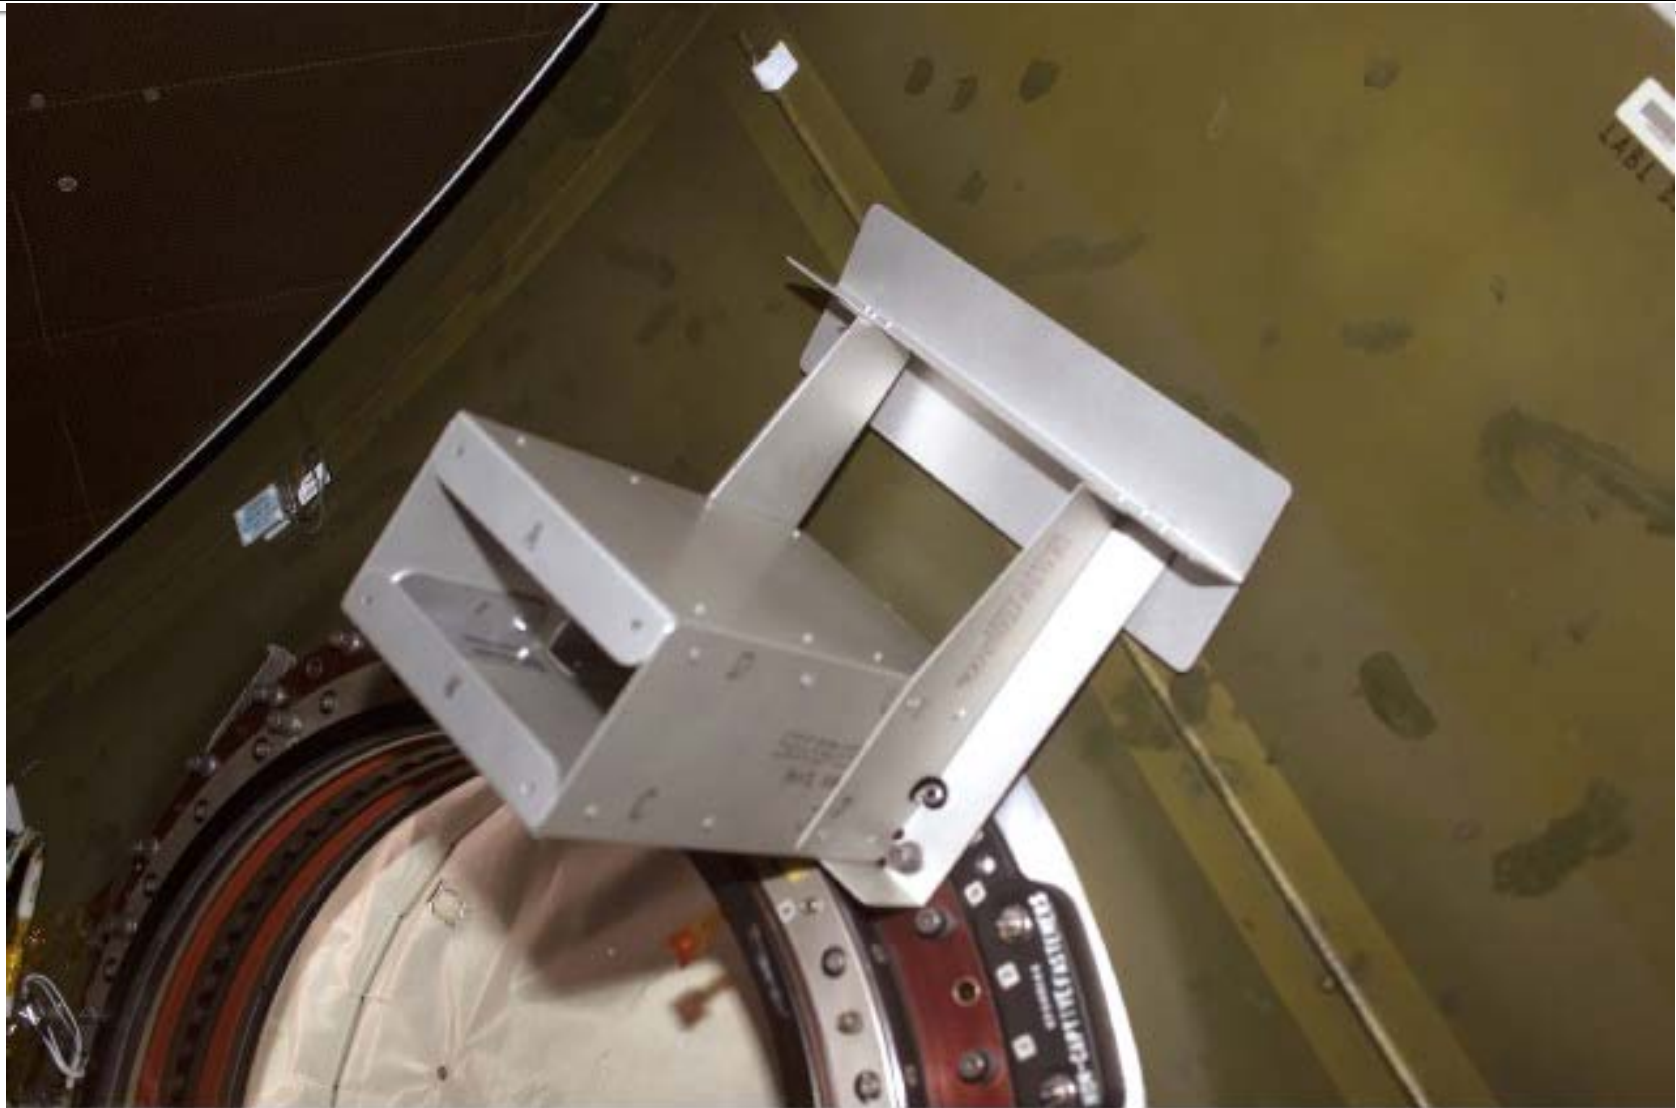
ISS009E17278

The Window Box

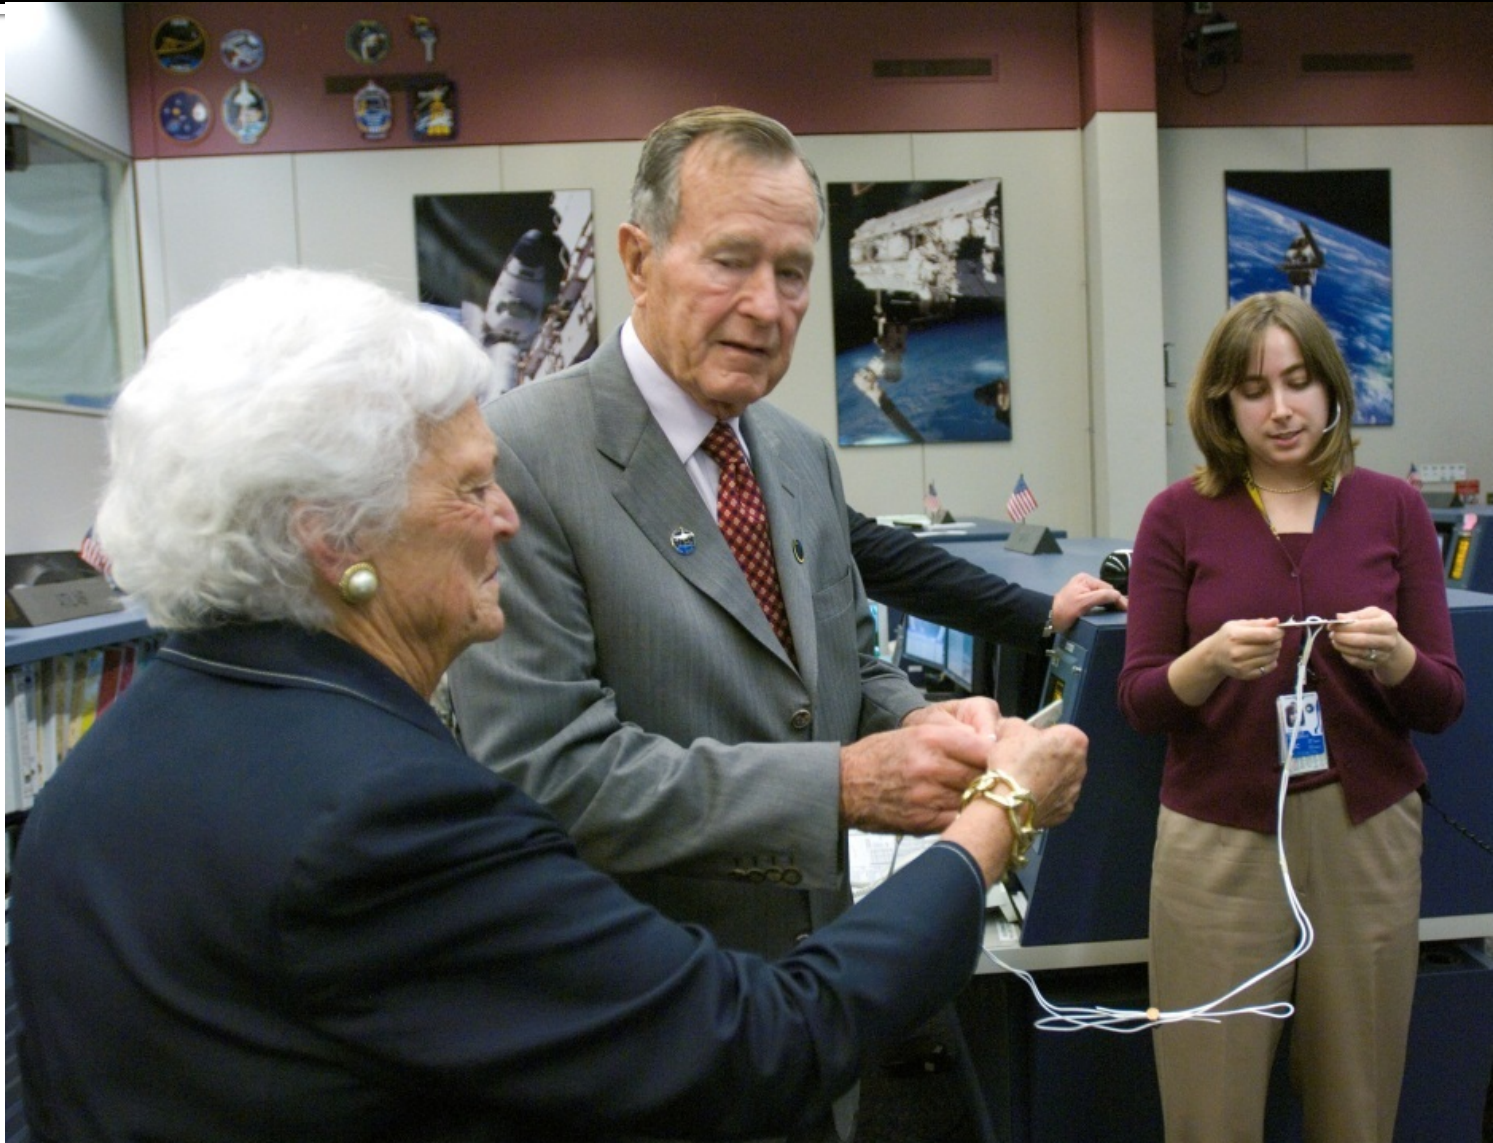
Solar Array Hinge Stabilizers ... a.k.a. Cufflinks

Solar Array Cufflinks Parts List

- Sharpie
- Ziplock Bag (two)
- Kapton Tape
- EVA Tape
- ISS Pin Kit: (two)
- Page 3
 - 12 Ga Wire (50 feet) (need approximately 66 feet total)
- Clamp and Bracket Kit:
 - 0.03" x 4" x 12" Aluminum (two)
- Large Gauge Pin Kit:
 - Small Split Bolt Connector P/N S-4

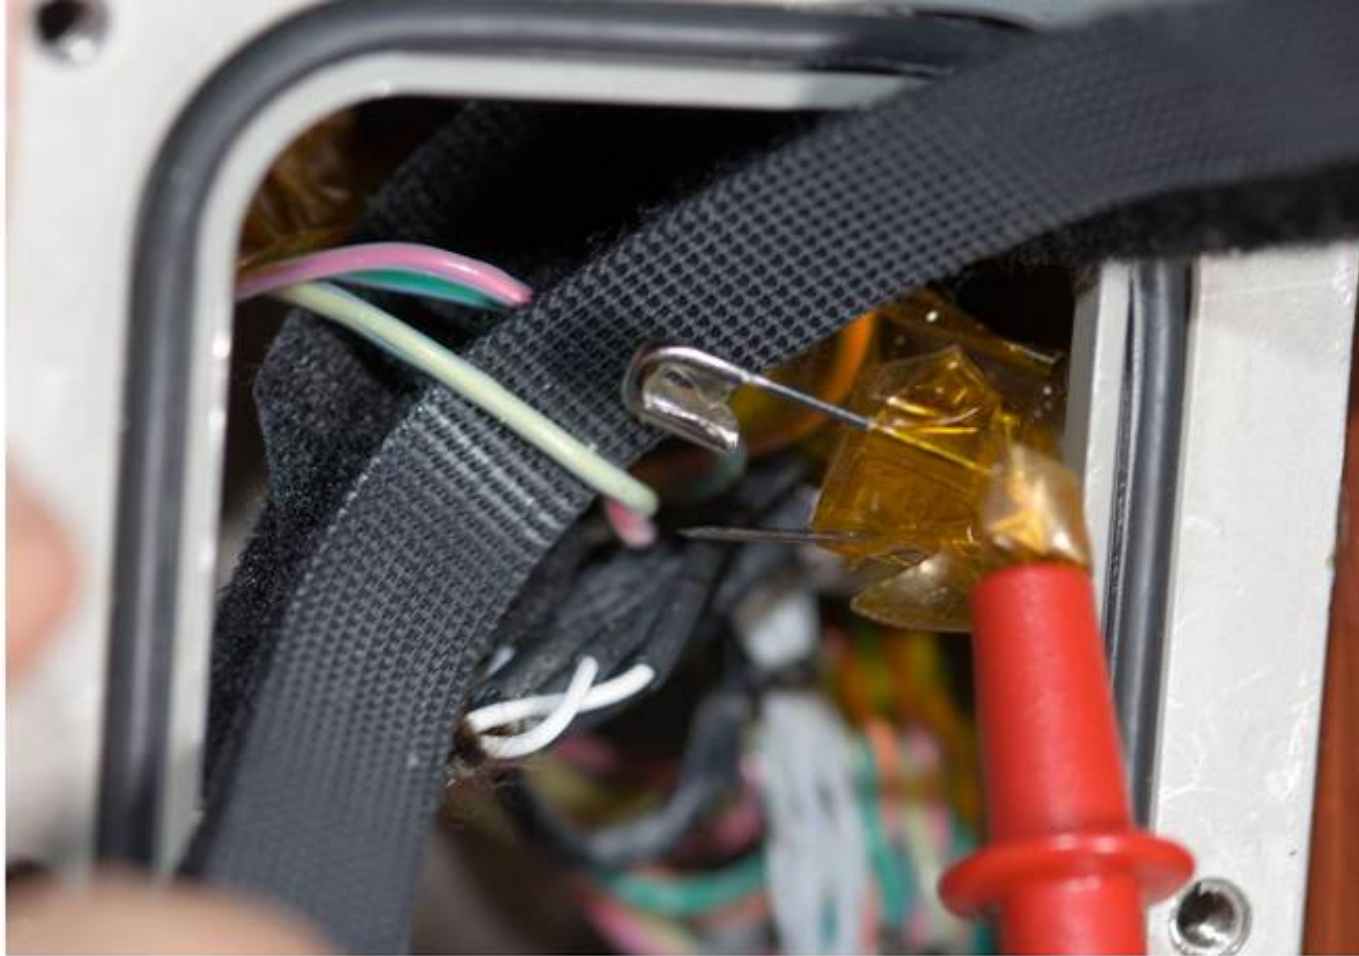
Test Twice, Cut Once (2009/Inc 20)

Tethered ACME Bolt

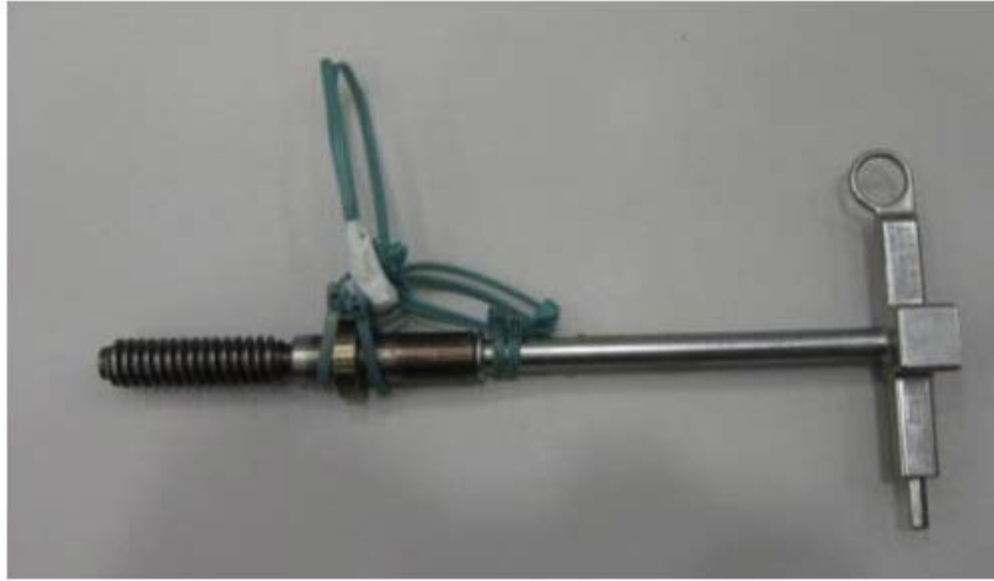
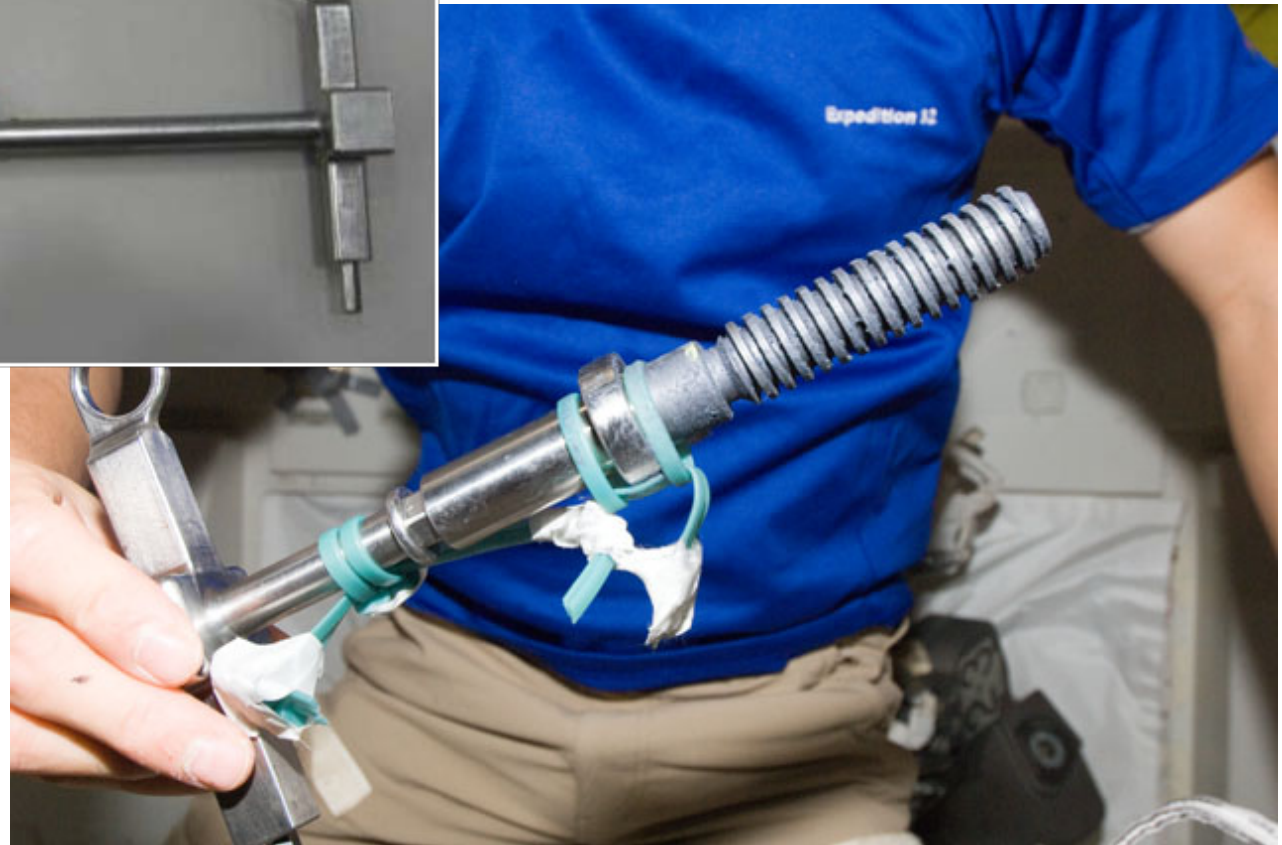
ACME Bolt Interface Tool

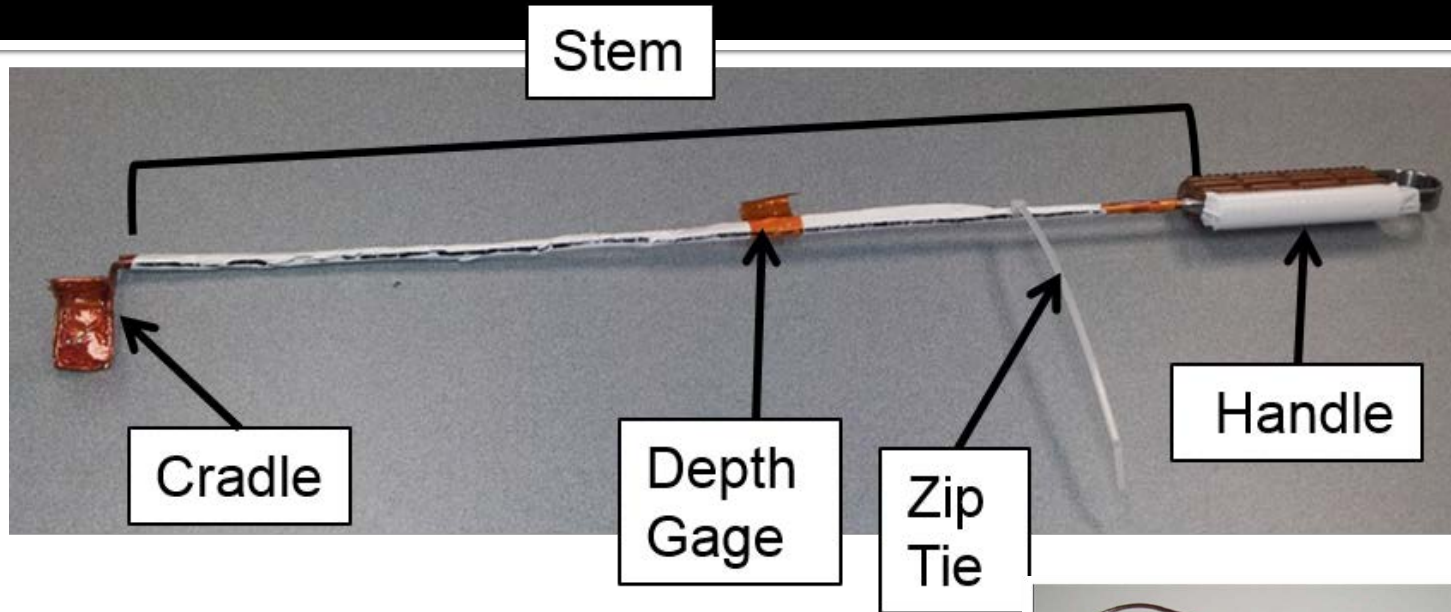
Ballscrew Lubing Tool (BLT)

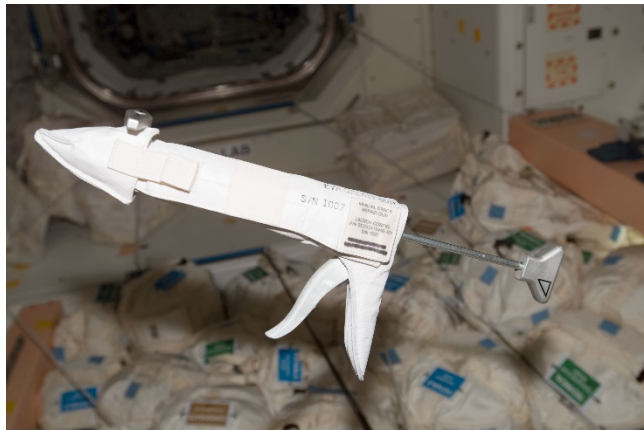
ISS017E007453

Space Grease Gun

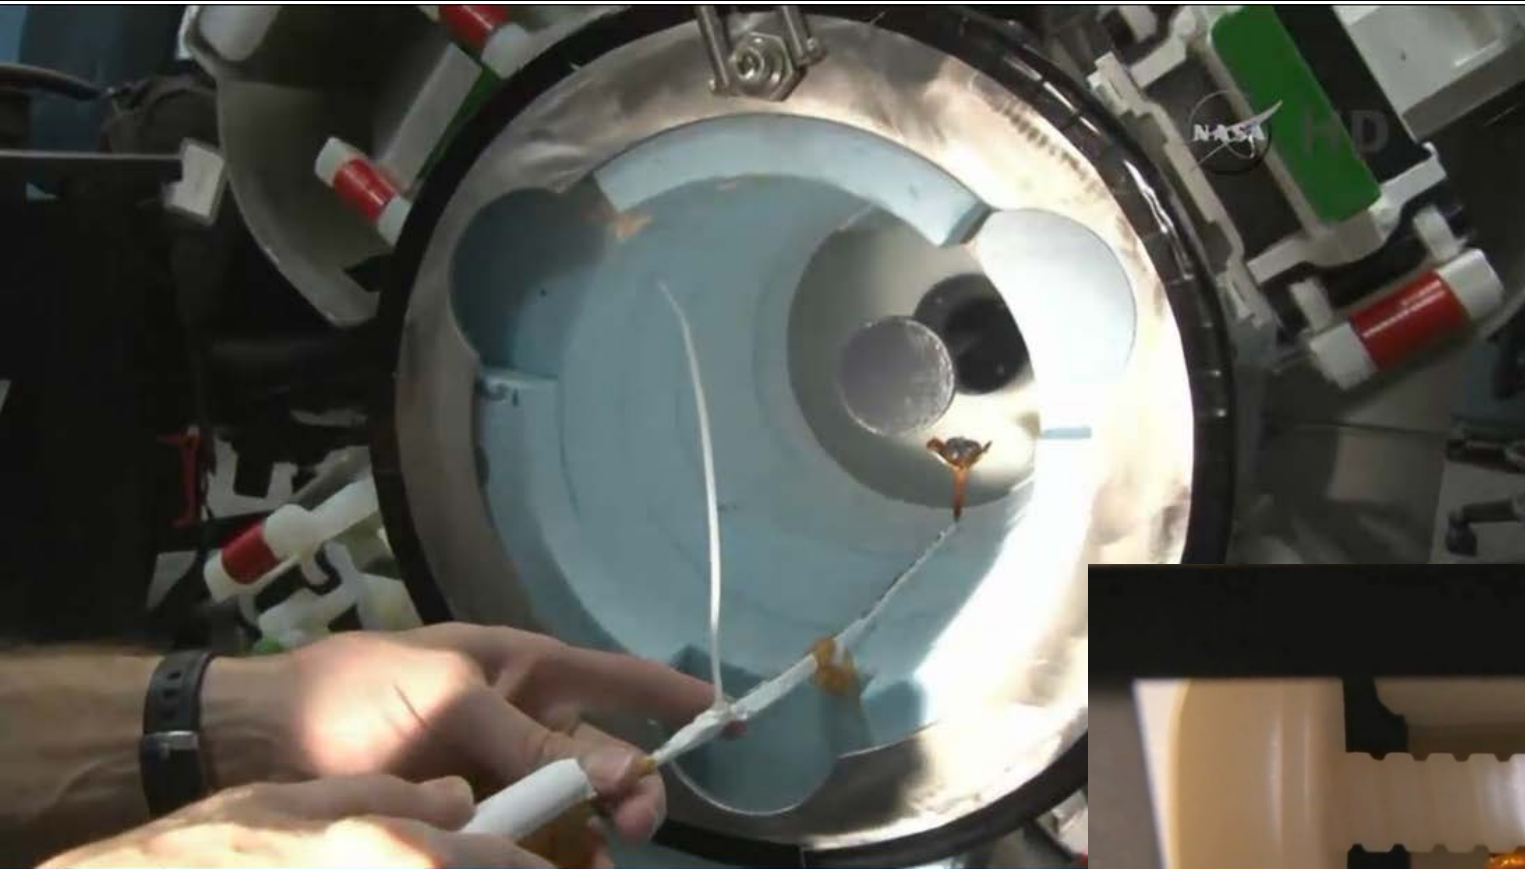
Ballscrew Lubing Tool (BLT)

Training to use the BLT on ground mockups of the LEE

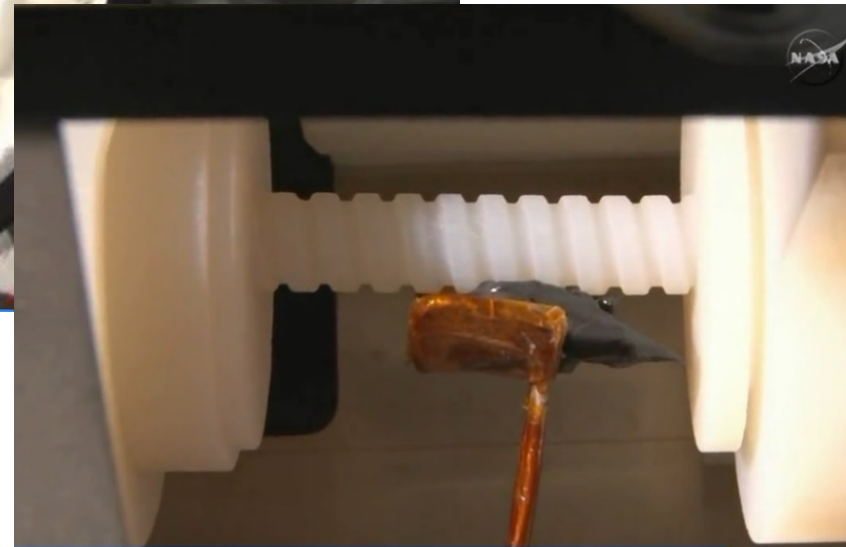
BLT On Orbit

The as built BLT on orbit, looked almost exactly like the ground built unit
